Middleborough Town Hall

Functional / Energy Assessment and Preliminary Strategic Energy Plan

Prepared by
Middleborough Green Energy Committee
Brian Kowalski CEM, LEED

July 2010

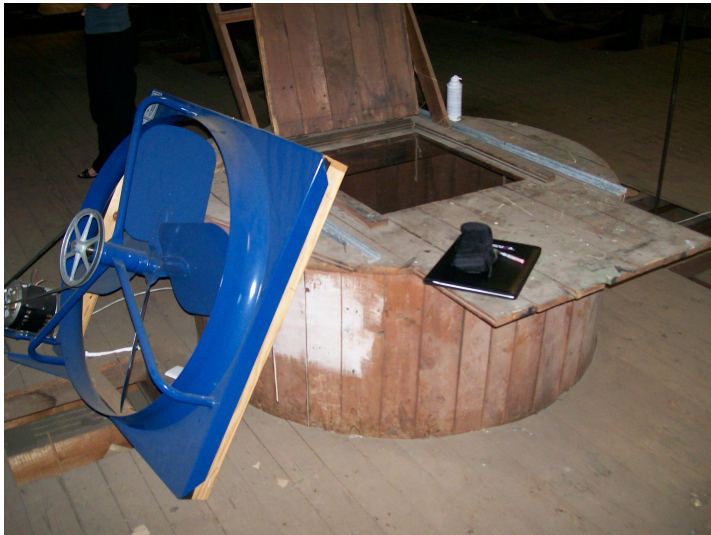
There are a significant number of sizable openings above the ballroom and stage area into the attic. These openings leak a considerable amount of warm air into the attic where it is then lost through the roof. See pictures below:

Vents above Chandeliers

These openings, combined with a heated second floor, contribute to the excessive heat loss and heating energy used for the town hall. Even if the measure for setting back the heat for the ballroom was implemented, the savings from sealing these large gaps would be worthwhile.

Implementation of this measure can be done in a very basic fashion or as a major repair/renovation to the ceiling in the stage area. The very basic fashion for patching the holes consists of using approximately 25 square feet of 6-mil plastic film, a staple gun, approximately 6 to 8 cans of expanding foam insulation, and a few hours of labor. Sealing the cupolas above

the chandeliers could be as simple as removing the nails someone installed to keep the sliding door on the top of the cupola open and shutting the sliding doors, or it could consist of fabricating new operable covers with better seals – the main thing is to get the big openings closed off.

Sealing these leaks and closing off these openings in a very basic fashion will cost less than \$500 to implement. Of course, if it were desired to renovate the ceiling or to fabricate new cupola covers, the cost would be considerably higher.

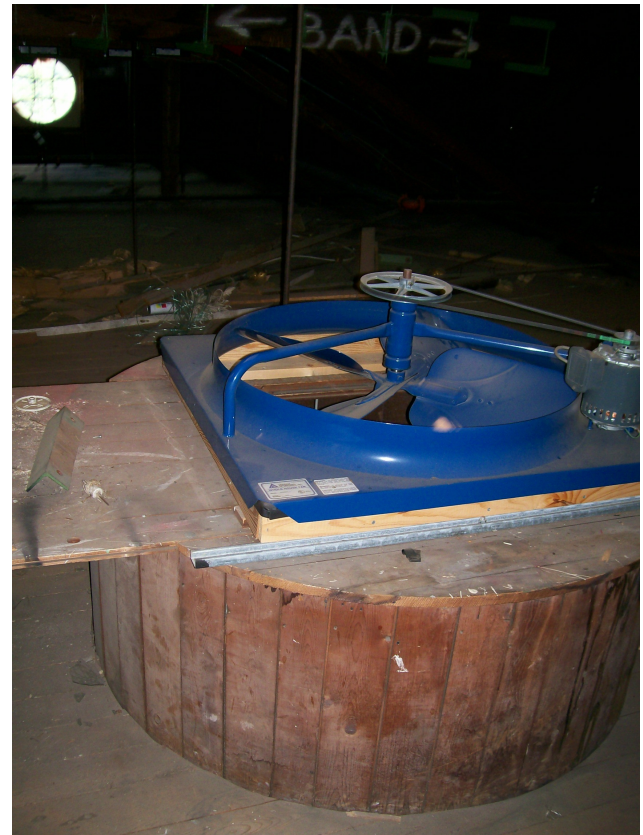
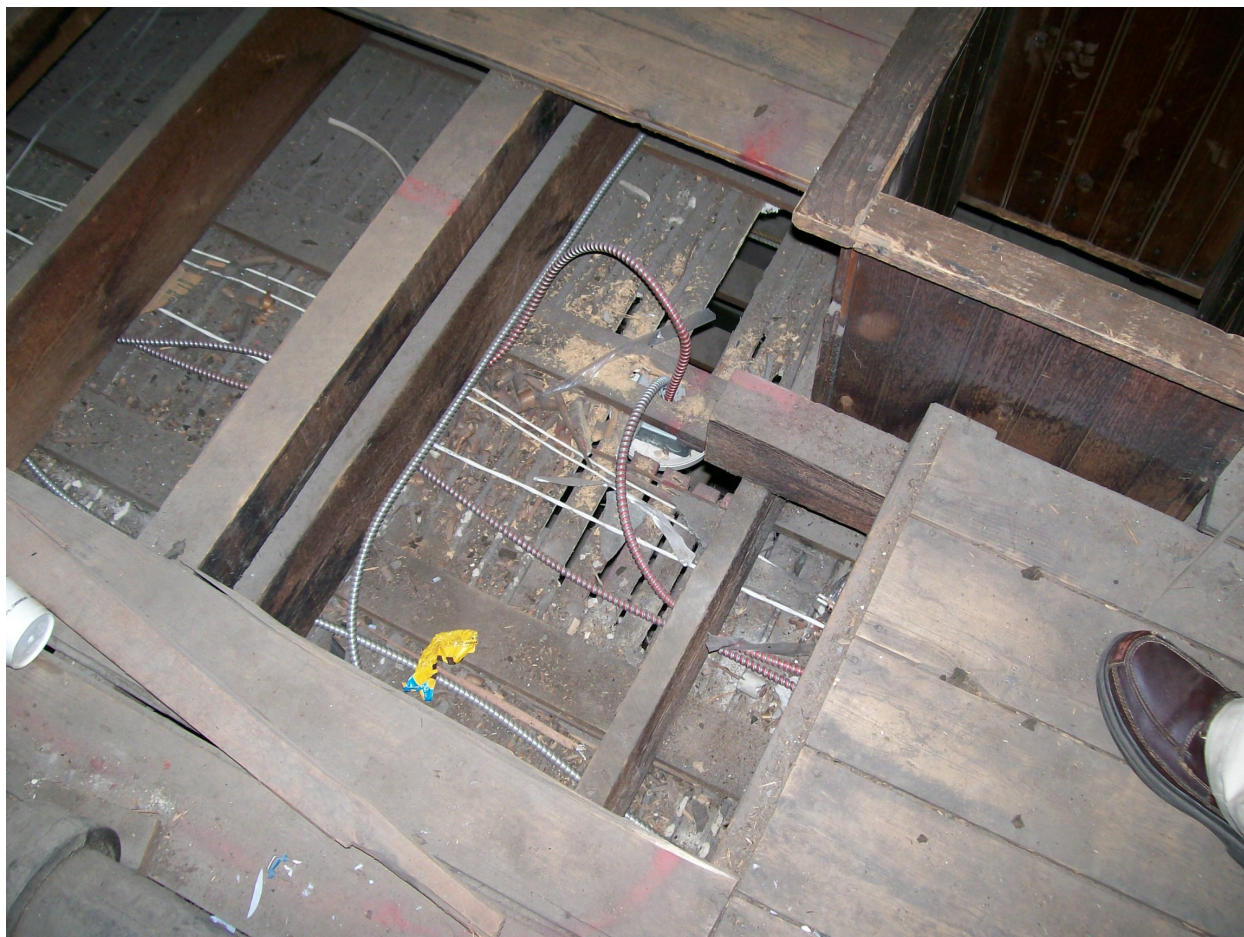
The picture below shows one of the numerous holes through the original lath and plaster ceiling as well as a chase for some sort of stage curtain/prop or line access that is both open and missing some trim that would provide a better air-seal around the chase.
